## Foreword

### Roofs & Rainwater Goods

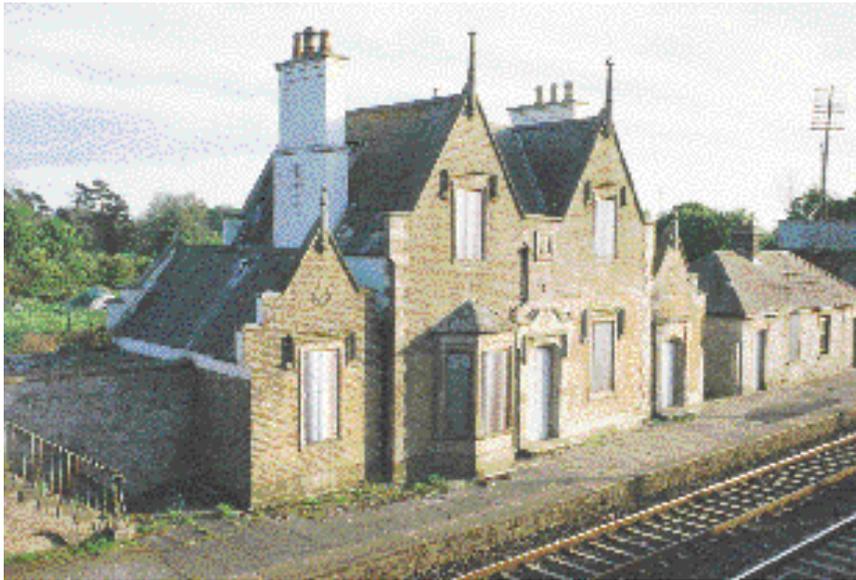
*Complex roof requiring repair and maintenance.*

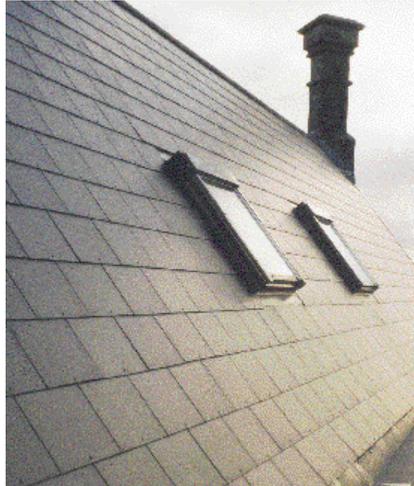
*Inappropriate artificial slates and obtrusive rooflights in historic building.*

Galvanised iron, roofing felt, asbestos cement sheets or slates, or artificial slates are inappropriate for the repair or replacement of natural slates.

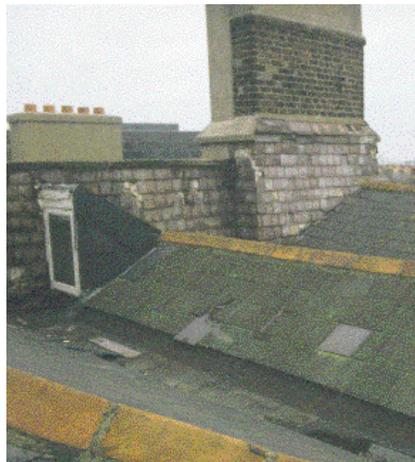
*Slate-hung walls in need of repair.*

External walls that are hung with slates or clay tiles should be carefully repaired and preserved, not only for their insulating properties, but as part of the historic fabric. Often the slates are of decorative shapes, and some may carry dates. Slipped or damaged slates or tiles should be carefully refixed, or replaced, as outlined above.

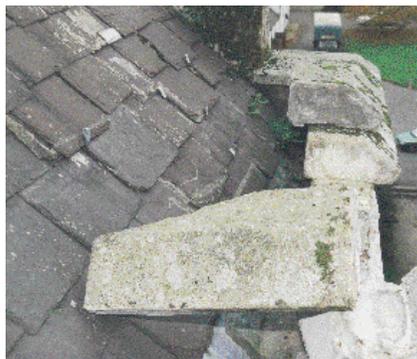
*Plant growth and damage, indicating presence of water, due to lack of flashing between roof and wall.*

The failure of these elements usually stems from simple problems - the incorrect fixing of the original sheets which were often too large, exacerbated by the contraction and expansion of the metal as the result of variations in temperature between day and night, and between summer and winter. If lead is cracked as a result of the use of oversized sheets or inadequate allowance for movement, "mending" the crack will not solve the problem and another will soon appear nearby; the only solution is to redetail the leadwork to correct the design fault. If lead is correctly detailed and specified, in accordance with the standards laid down by the relevant authority, then it should last for a very long period indeed - several hundred years in many cases - and is only vulnerable to human damage and maltreatment.

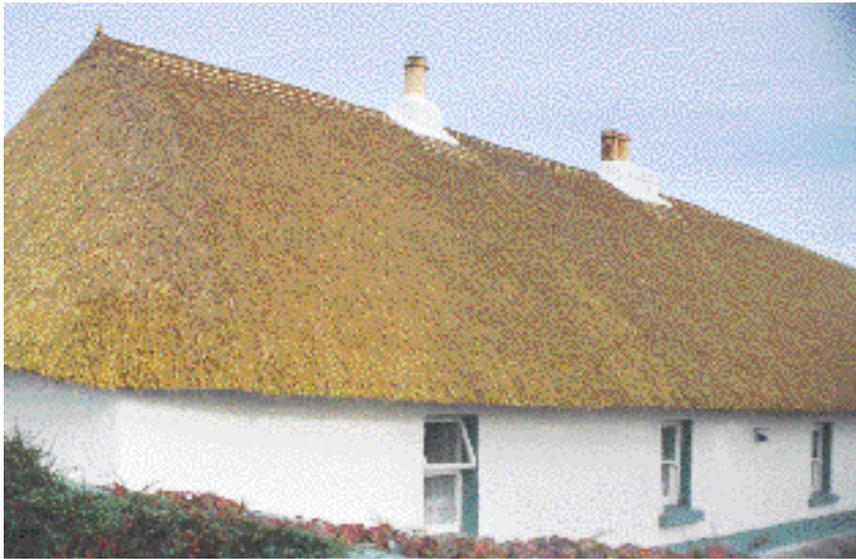
*Newly thatched cottage.*
